Pavement Management Plan

**Village of Lake Zurich
Lake County, Illinois
January 26, 2015**

VILLAGE OF LAKE ZURICH PAVEMENT MANAGEMENT PLAN

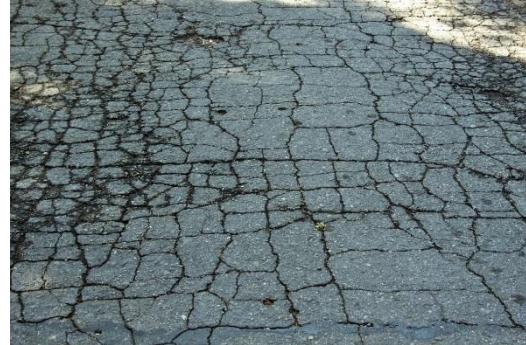
Fatigue Cracking is a series of interconnected cracks forming many sided pieces resembling the skin of an alligator (fatigue cracking is also known as Alligator Cracking) and is caused by the inability of the pavement structure to sustain the repetitive traffic loading (fatigue). Alligator cracking is usually associated with either drainage problems of the base materials or insufficient thickness of the pavement structure for the traffic utilizing the pavement. Alligator cracking only occurs in areas subjected to repeated loading. For arterial roads (State or County Roads) this tends to be the wheel paths, however residential traffic tends to use all parts of the pavement and alligator cracking can occur almost anywhere in the pavement. Small areas may be fixed with a patch or area repair. Larger areas require reclamation or reconstruction as the distress derives from base problems. Drainage must be carefully examined in all cases.

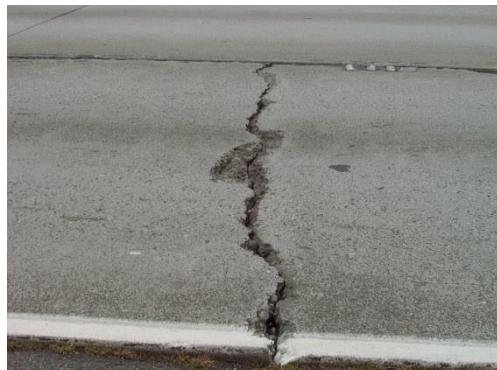
Transverse Cracks form at right angles to the centerline and are created by contraction of the pavement due to cold temperatures. The cracks initially occur at long consistent spacing intervals, approximately 50 to 100 feet apart. As the pavement ages, its exposure to the elements causes it to harden and become brittle (sometimes termed "Oxidation"), no longer allowing the pavement to expand and contract with changes in temperature. Over time, the crack spacing interval becomes smaller and at about 10 feet spacing, the cracking is termed "Block Cracking." Left untreated, the width of the cracks will expand, allowing water to enter and infiltrate the base material. When subjected to repeated traffic loading, alligator cracking forms. Transverse and Block Cracks should be filled or sealed when the cracks are narrow and not too deteriorated. Multiple cracks or alligatoring may require patching. Periodic surface treatment will slow the age hardening of the asphalt binder and retard development of thermal cracks.

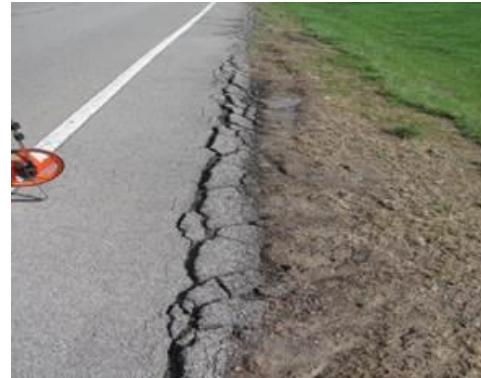
Edge Cracking is parallel to the edge of pavement / curb and gutter and is generally within a few feet of the pavement edge. Edge cracking usually results from the lack of support due to weakened base material from excessive moisture. Similar to other cracks, untreated cracks will widen, allow infiltration of water to the base materials and when subjected to repeated traffic loading, alligator cracking will form. At low severity, the cracks may be filled. However, as the severity increases, patches and replacement of the distressed areas may be required. In all cases, excess moisture should be eliminated.

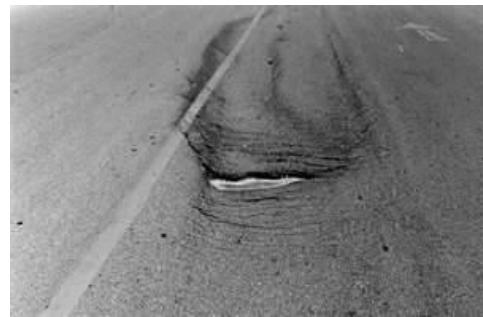
Shoving is a longitudinal displacement of an area of the pavement surface caused by traffic loading. When traffic pushes against the pavement, it produces a short abrupt wave in the pavement surface. Shoving is normally attributed to asphalt mixtures with too much asphalt cement or fine aggregates. Minor shoving areas can be repaired by patching; larger areas may require milling and resurfacing.

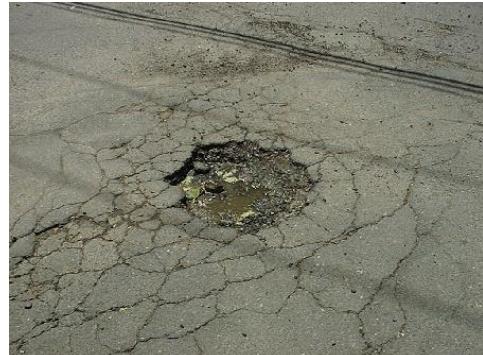
Potholes are localized holes or voids that form in the pavement structure. Potholes start as fragments of the asphalt surface dislodge, and over time continue downward into the lower layers of the pavement. Potholes are formed when the pavement disintegrates under traffic loading due to water related issues in one or more layers of the pavement. Pothole often appears after rain or during thaw periods when pavements are weaker. Potholes should be patched by removing the deteriorate asphalt pavement and replacing with new materials. Area repairs or reconstruction may be required for extensive potholes along with an investigation of potential drainage issues.

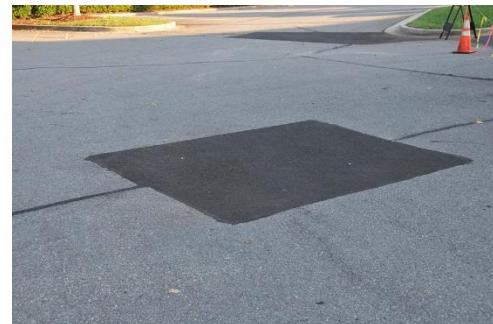
Patches are portions of the pavement that has been replaced with a new material to repair the existing pavement or to cover a utility trench. The edges of patches inherently introduce cracks to the pavement. If these cracks expand, water will enter the patch and degrade the pavement base, causing the patch to fail again. Additionally, if the patch did not correct a base or subgrade problem that originally existed, the problem will continue and the area will eventually fail. Patches over utility trenches often settle when the base material is not compacted adequately and settlement occurs. A deteriorating patch needs to be expanded and repaired.

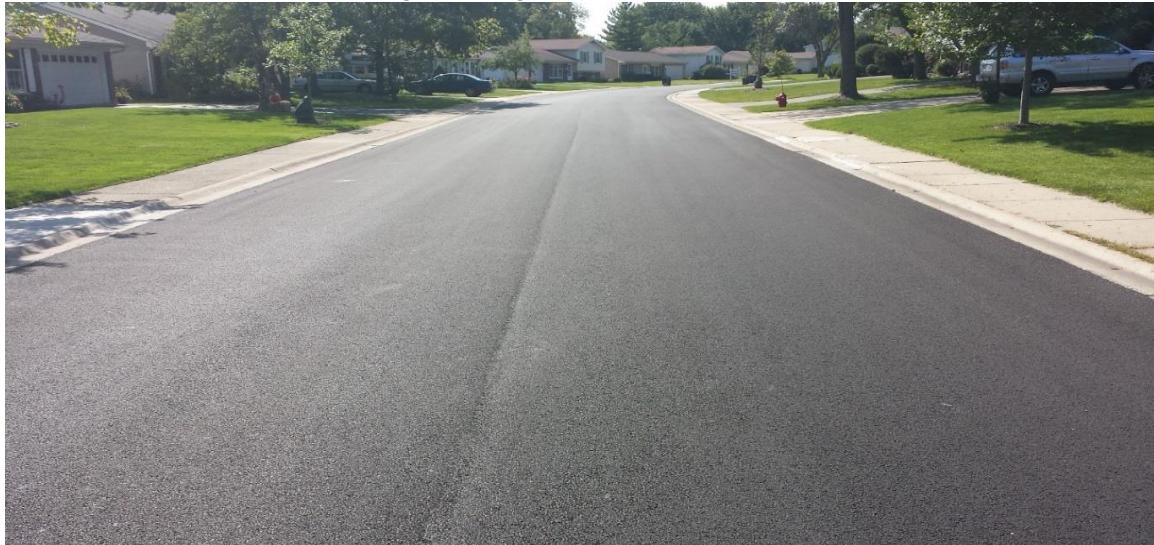
Figure 7 - Ginger Tr (Excellent)

If a pavement section is categorized as “excellent”, it will have been recently resurfaced or constructed. In most cases no maintenance is required, however the Village may choose to be proactive by crack sealing along the curb line and center seam to prevent seepage into the base of the road.

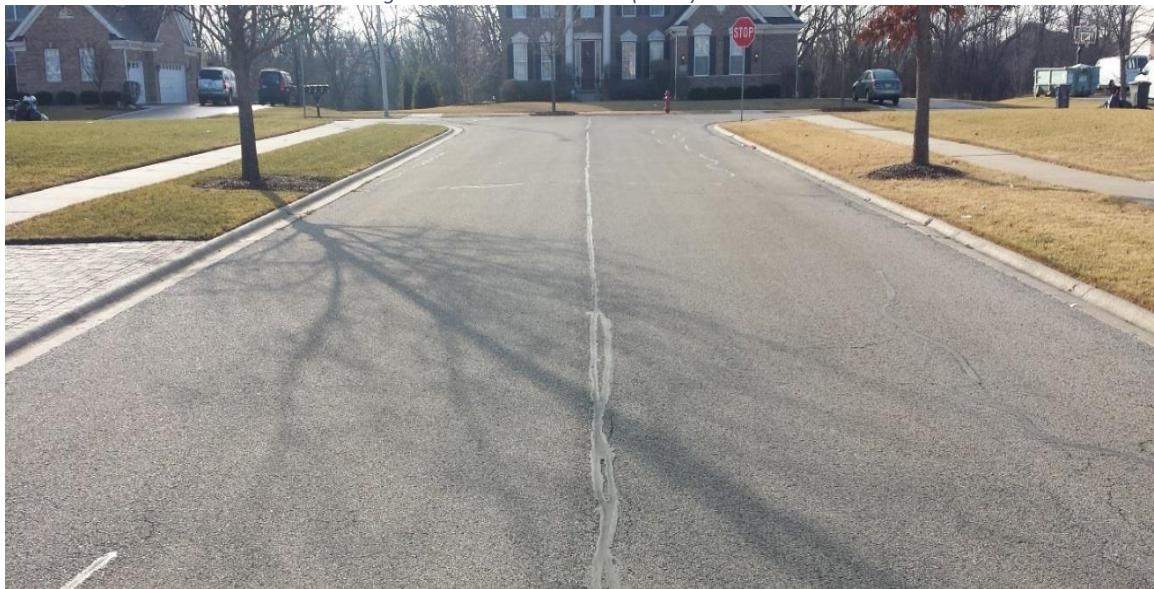
Figure 8 - Orchard Pond Dr (Good)

Streets with a rating of “good” are usually 3-6 years old, and have experienced enough freeze thaw cycles to show signs of increased distress. While the distresses may still be relatively minor, they are prime candidates for preventative maintenance techniques. It is recommended that the Village use a combination of crack sealing, asphalt rejuvenator, and spot patching to restore deteriorating areas of the roads.

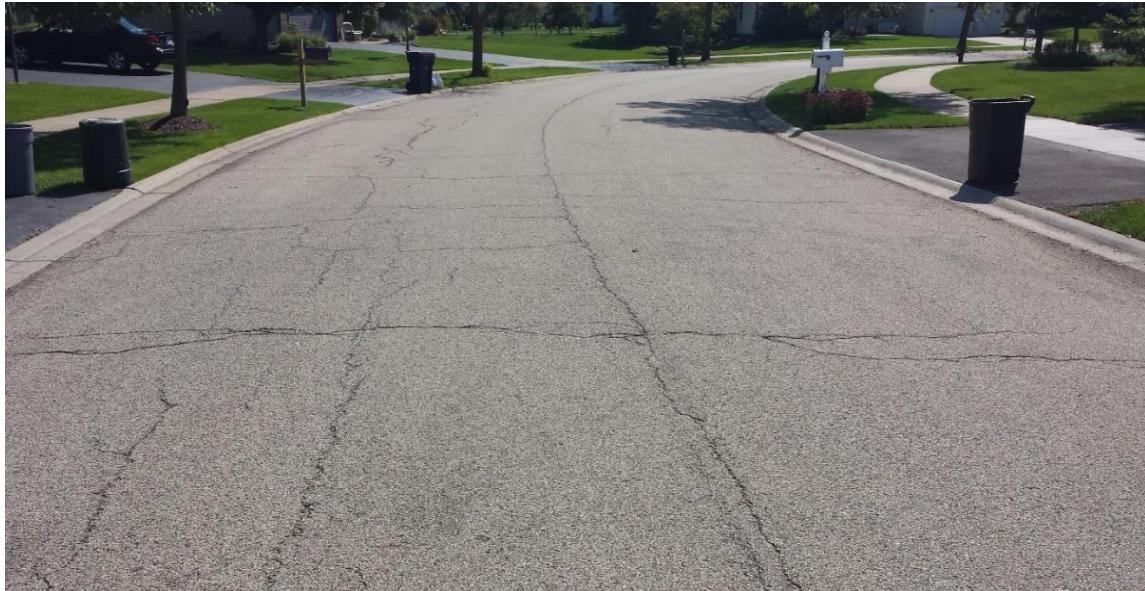
Figure 9 - Foxmoor Ln (Satisfactory)

It is at this point in the pavement's lifecycle that there will be distresses ranging from low to high severity. Maintenance tactics such as crack sealing and asphalt rejuvenation likely will not be effective, as the structural integrity of these streets has typically been compromised. Streets in the satisfactory and poor categories are recommended to be rehabilitated utilizing several strategies including area spot repair of failed base, pavement patching, resurfacing or overlay of existing asphalt pavement.

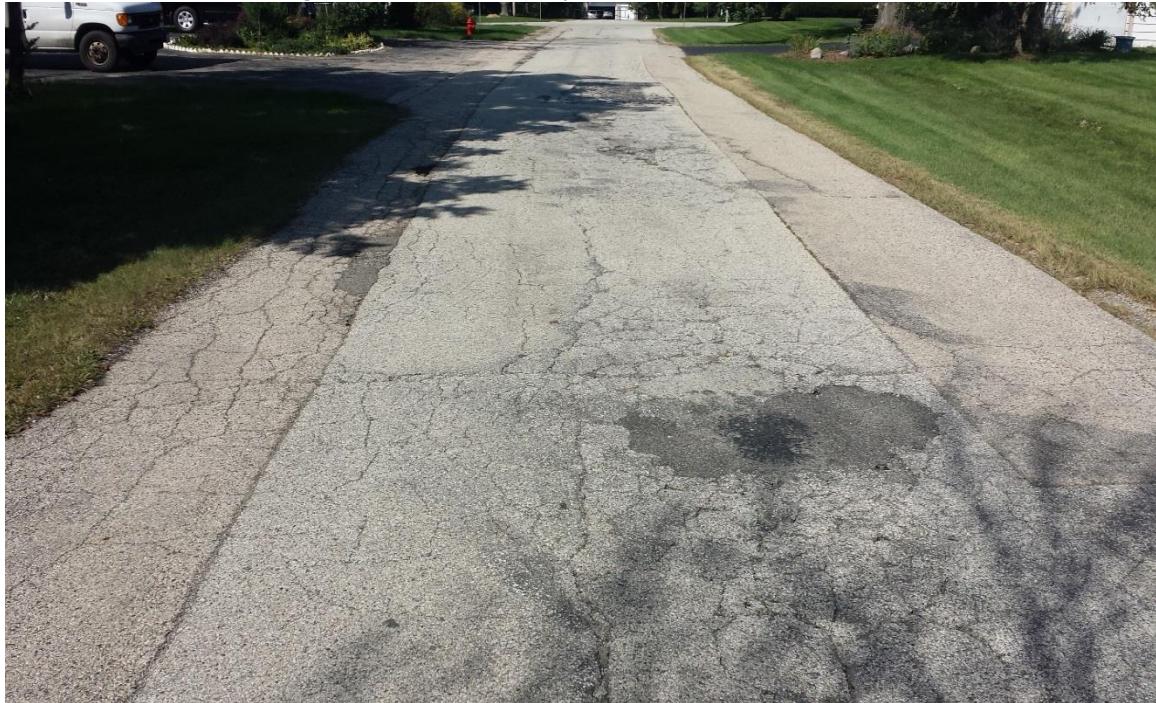
Figure 11 - Edelweiss Dr (Very Poor/Serious/Failed)

When the PCI rating is 40 or below, the street will be showing high severity distresses at multiple locations. Rehabilitation for these streets can become very costly, so every effort should be made to keep streets from entering into these categories. Typically, streets of this category will need to have extensive rehabilitation performed or will require reconstruction. The extensive rehabilitation methodologies could include base repair with full-depth pavement patching, pulverization of existing asphalt pavement with placement of new asphalt pavement, or resurfacing of the full asphalt pavement thickness. If the street has deteriorated to the point where the structural integrity has completely diminished, reconstruction is the recommended course of action. Reconstruction involves removing the pavement at full depth, through the surface layers of asphalt and into the stone base, and constructing the street to its original state. **While resurfacing costs on average \$4.00/sq. ft., reconstruction can cost upwards of \$8.00/sq. ft.** In extreme circumstances, reconstruction is necessary, however rehabilitation techniques can be implemented in the earlier stages of the pavement deterioration process which can remedy structural failures without the need for an expensive reconstruction.

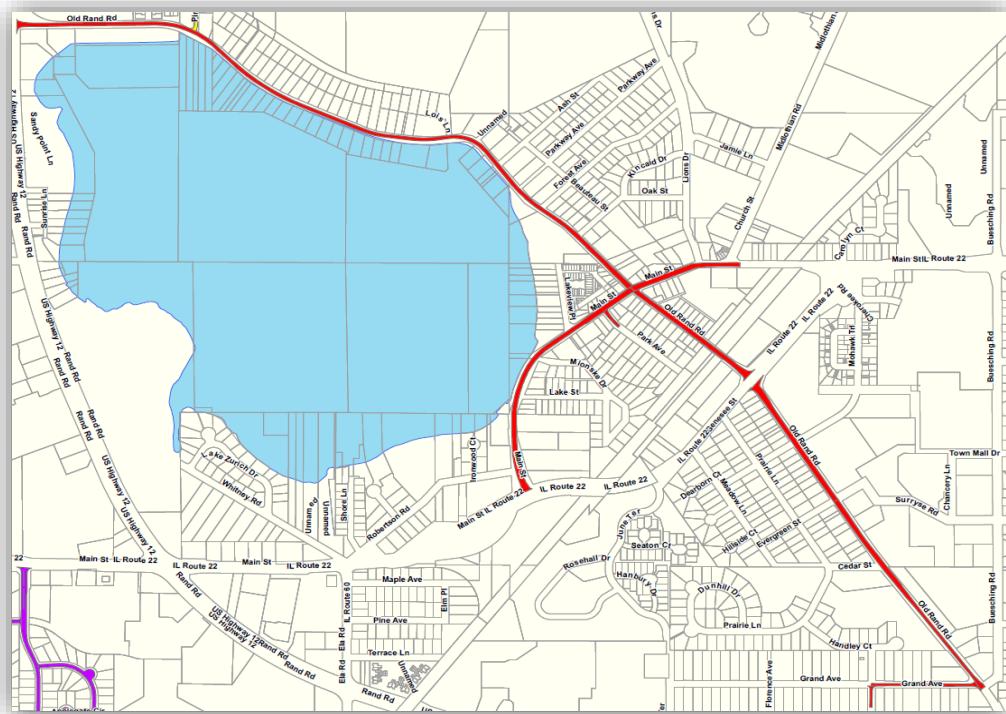
Figure 17 - 2018 Road Program

Main Street and Old Rand Road are both high volume roadways and major thoroughfares for the Village of Lake Zurich. Main Street shows signs of base failure, but the issue is not widespread. Mill and overlay with patching on both Main Street and Old Rand Road will likely provide sufficient repair. Small sections of both Park Avenue and Edelweiss Drive are in disrepair, and have been added to the 2018 Road Program due to their proximity to the project and severity of distresses. Grand Avenue is also included in the road program due to its proximity to the project, and will require a thin mill and overlay.

Main Street is poised to undergo major commercial improvements in the coming years, and depending on Village instruction, 2018's proposed road program may be pushed back until large construction equipment will no longer be using the road on a regular basis. However, Main St is currently at a 41 PCI (Poor), which could be as low as a 31 PCI (Very Poor) by the projected road program date. The street life may be extended with the use of patching, however regardless of commercial development in the downtown area, Main St and Old Rand Rd should be rehabilitated within the next 4-7 years.
